Wildlife Field Notes

Don't Fence Me In

Introduction and Design Considerations

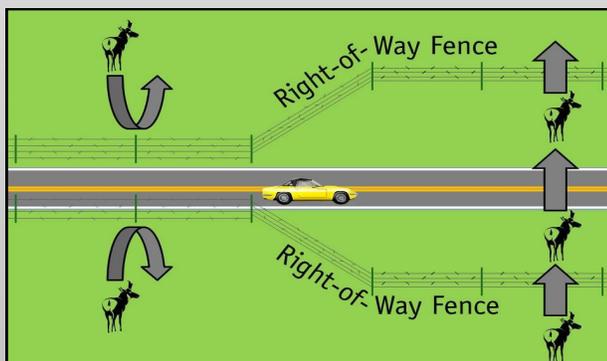
Figure 1. Schematic showing fences moved back to allow pronghorn to stage before crossing the road.

Studies by the Arizona Game and Fish Department's (AGFD) Wildlife Contracts Branch have shown that fenced roadways form almost complete barriers to pronghorn movements and contribute to pronghorn habitat fragmentation. Habitat fragmentation, caused by roads, canals, fences, and human developments of all kinds, is a known factor globally in animal population declines and undoubtedly contributes to pronghorn declines in Arizona. In the 1990s, AGFD researchers theorized that roadways closely flanked by right-of-way fences were pronghorn movement barriers. It was hypothesized that pronghorn could not cross the fence-road-fence combination when all three obstacles were in proximity. However, if the fences were moved away from the roadway, creating a "staging space" between the obstacles and providing pronghorn time to negotiate those obstacles, the combined barrier effect would be negated or minimized and pronghorn could safely cross the road (Figure 1). Without the away-from-the-road staging

space, pronghorn refuse to cross or get alarmed by approaching traffic and bounce back and forth from fence to fence across the road, resulting in collisions and mortalities.

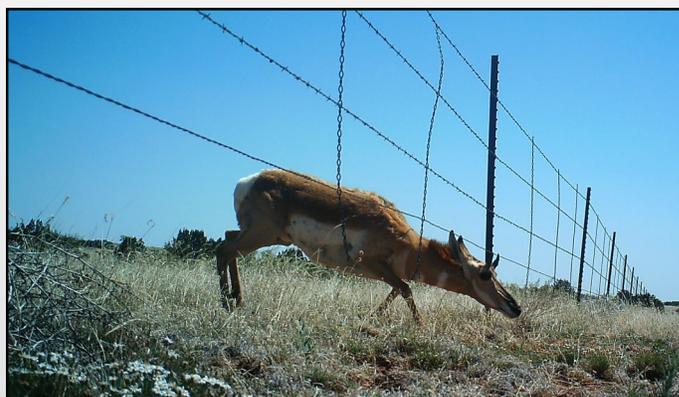
Figure 2. Because pronghorn almost always go under fences, characteristics such as a smooth bottom wire are important.

In addition to the staging space, the type of fence along the roadway is also important. Although pronghorn are fleet animals, they rarely jump fences. They evolved in open grasslands with no barriers to jump and escaped danger by detecting it through keen eyesight and then simply out-running the threat. Today, when pronghorn come to a fence, they almost never jump it but, instead, go under the bottom wire, if they can. So the type and design of the fence is important to the ability of pronghorn to pass under it. Studies have shown that the bottom wire should be at least 18 inches from the ground and is best if smooth and not barbed.

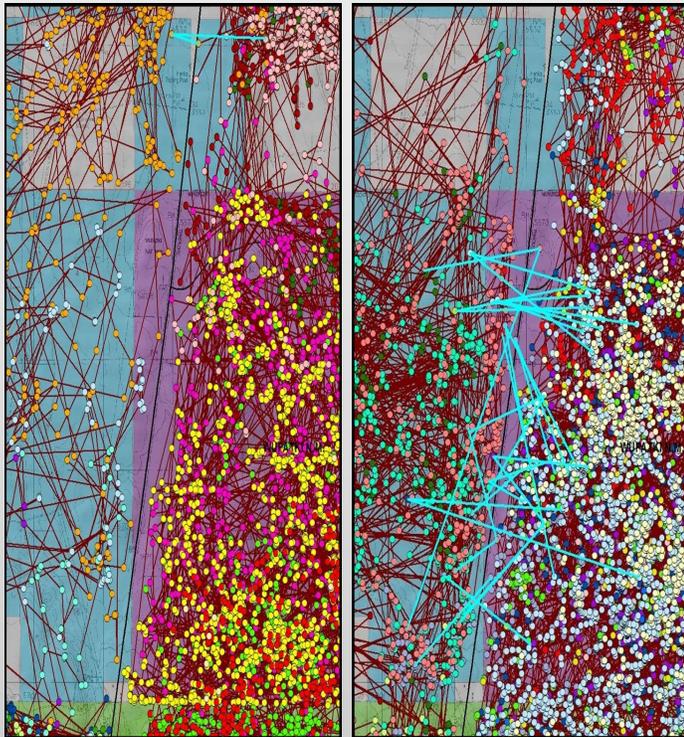
Figure 3. Map of US 89 through Wupatki National Monument showing only one pronghorn crossing when roadway fences were up (left) and numerous pronghorn crossings when fences were taken down (right).

Before fence removal, only one of 37 marked pronghorn had crossed the road. After removal, nearly half of the marked pronghorn crossed the road, supporting the hypothesis that roads and their immediately adjacent right-of-way fences fragment pronghorn habitat and that by removing these fences, or by creating a staging space between them and the roadway, the barrier effect is negated (Figure 3).

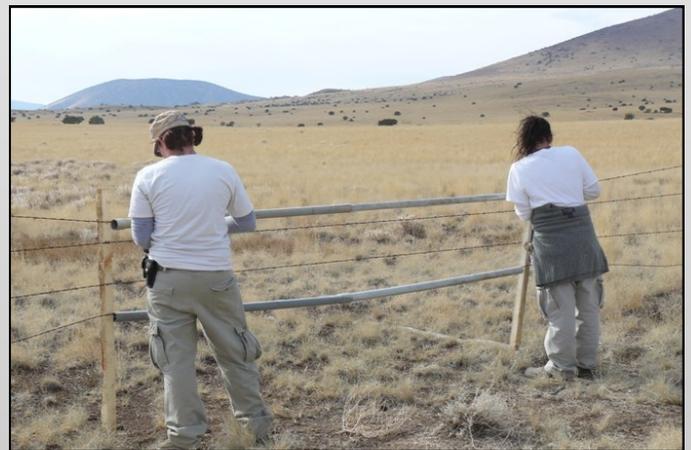
Figure 4. Raising the bottom wire of a fence and covering it with a “goat bar” facilitates pronghorn movement.

AGFD biologists have shared the results from the Wupatki National Monument experiment with the United States Forest Service and the Arizona Antelope Foundation, as well as with other agencies, organizations, and volunteer groups, all of whom have contributed to the fence removal experiment. Treatments now include moving fences away from roadways, removing or modifying pasture fences by replacing barbed bottom wires with barbless wire set at 18 inches from the ground, and adding “goat bars” (Figure 4) that visually indicate a location where pronghorn can cross under a fence. AGFD biologists are currently in the process of outfitting more than 60 pronghorn with GPS collars to assess the effectiveness of these new fence modifications and will share the results in a future Field Notes.
